Hello Sarah,

STATE OF VERMONT  
 Division for Historic Preservation  
 Montpelier, VT 05602

HISTORIC SITES & STRUCTURES SURVEY  
 District  Complex  Survey Form

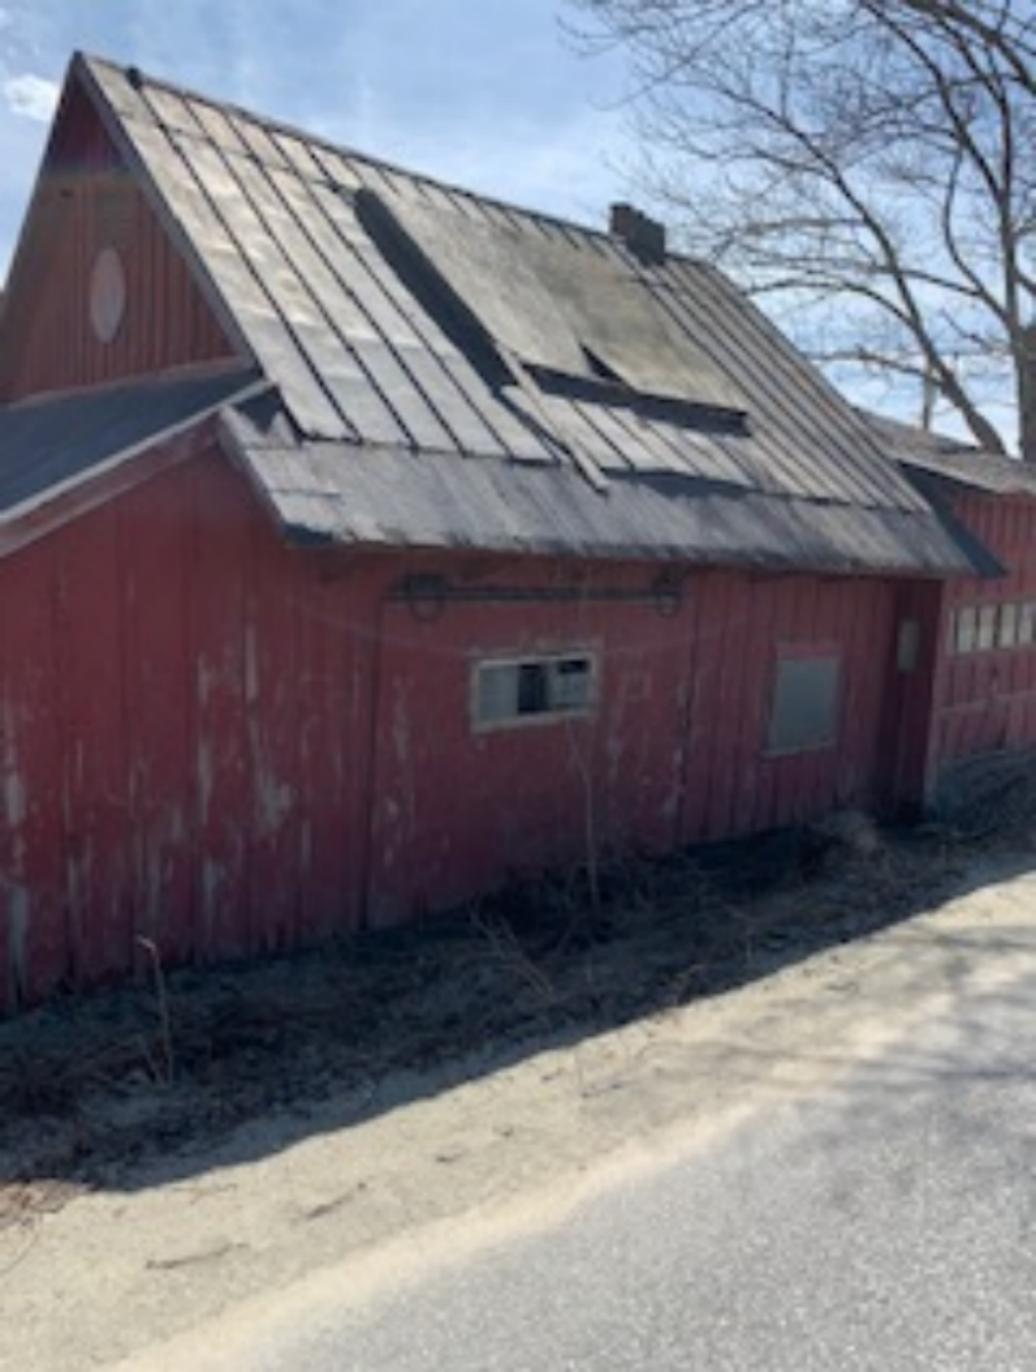
Attached are the photo's as evidence:

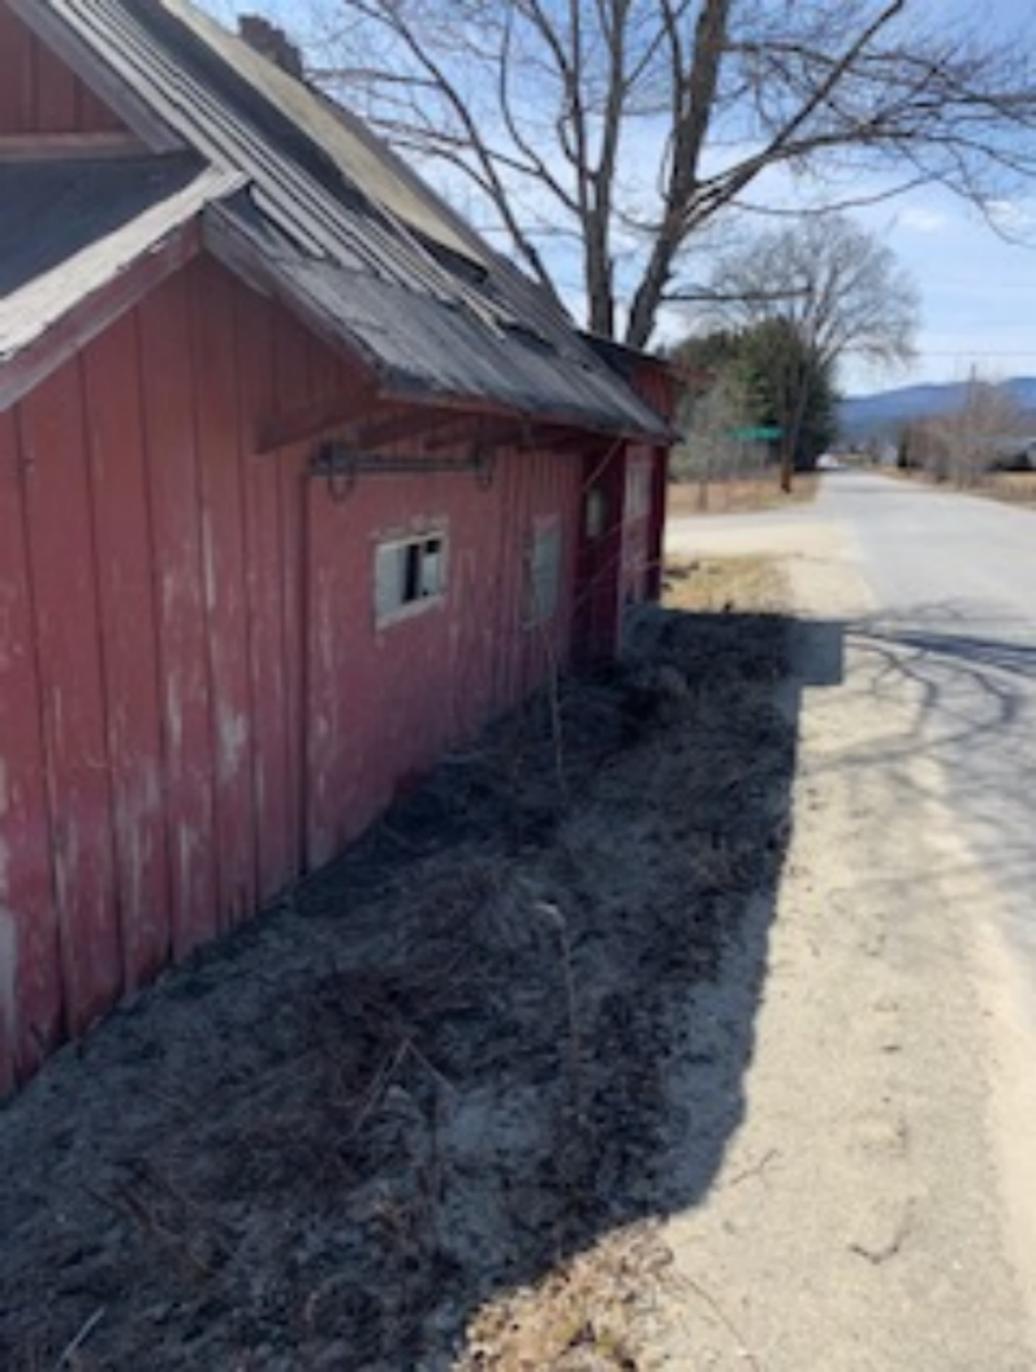
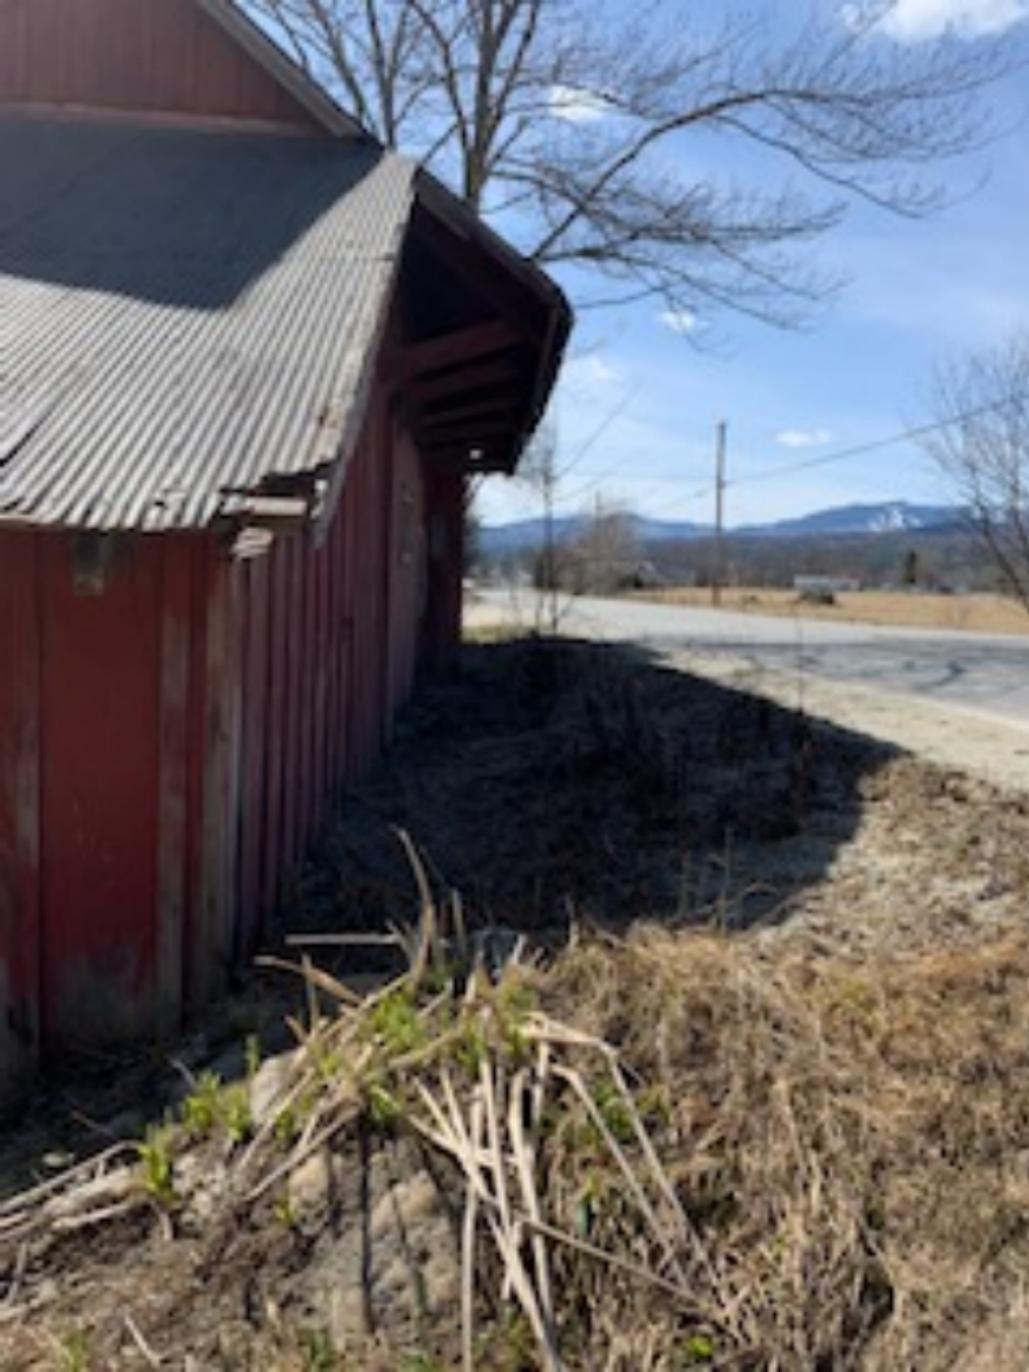
Photo#1: shows the close proximity to Randolph road and the compromised roof, which, should it let go again, could cause serious injury to anyone traveling on Randolph rd.

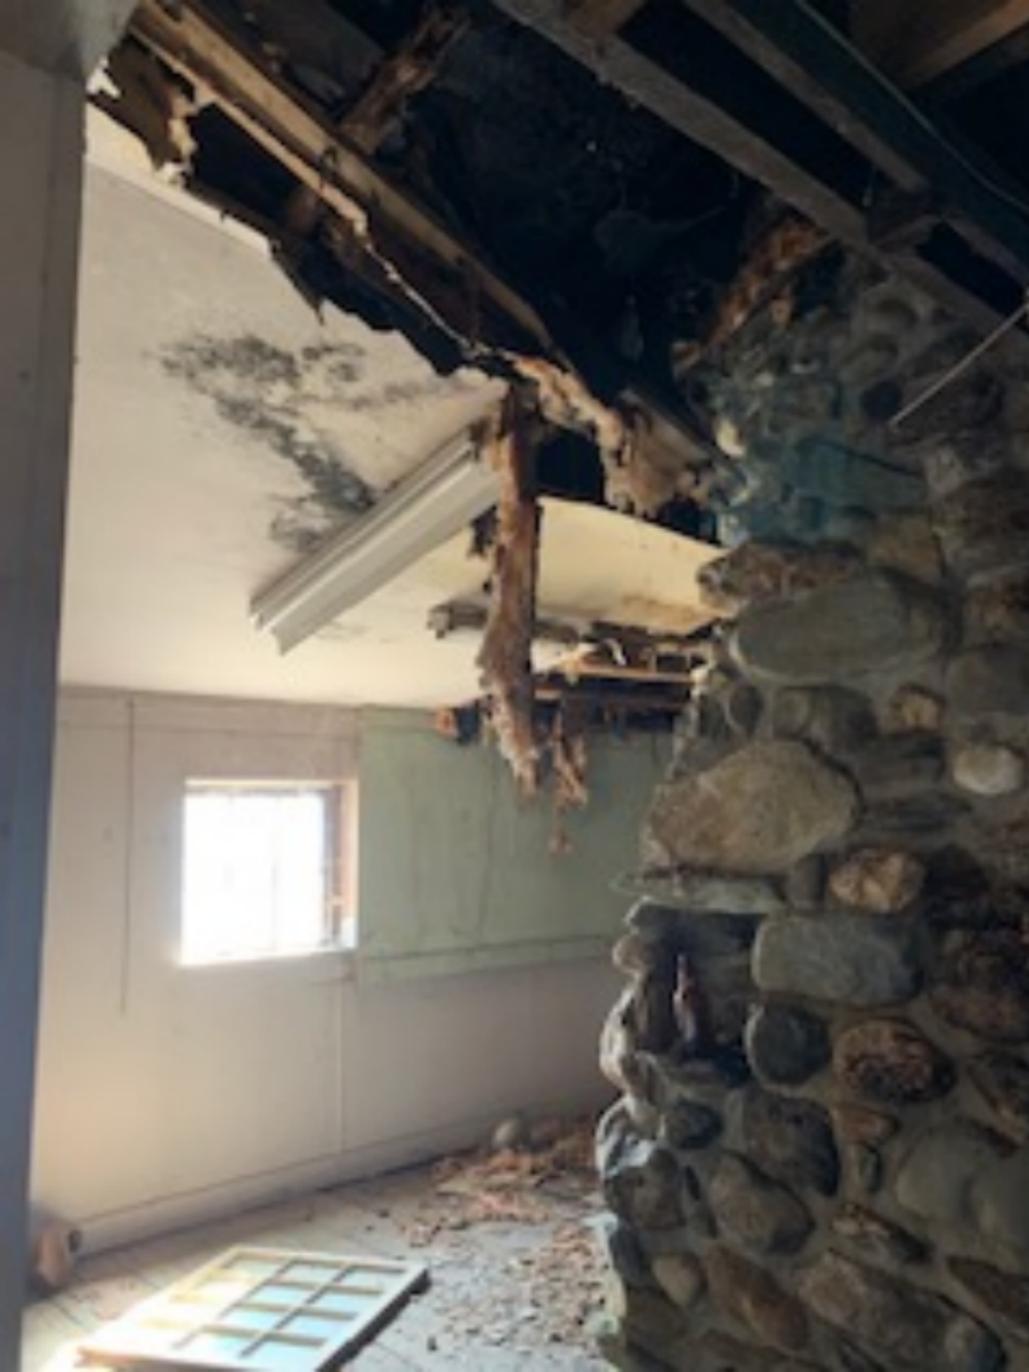
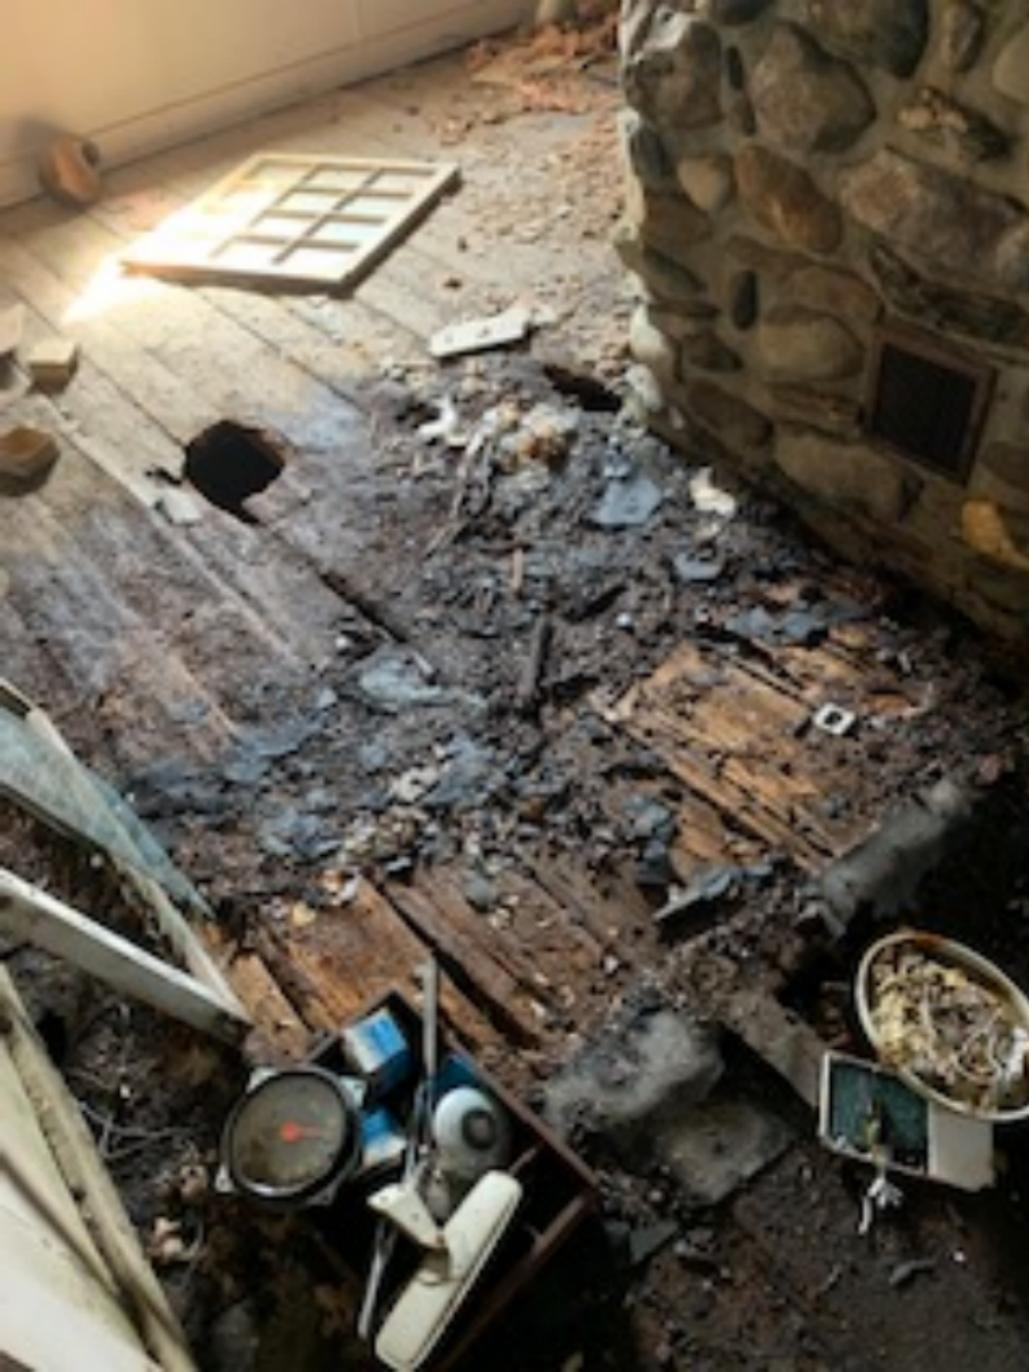
*Photo #2&3: more proximity shots, better illustrating the reverse grade from the road to the structure. In this picture, the substantial ditch is actually filled with winter snow/ice from plowing, and it rests against the structure, accelerating the degradation of the wood sill and front wall.*

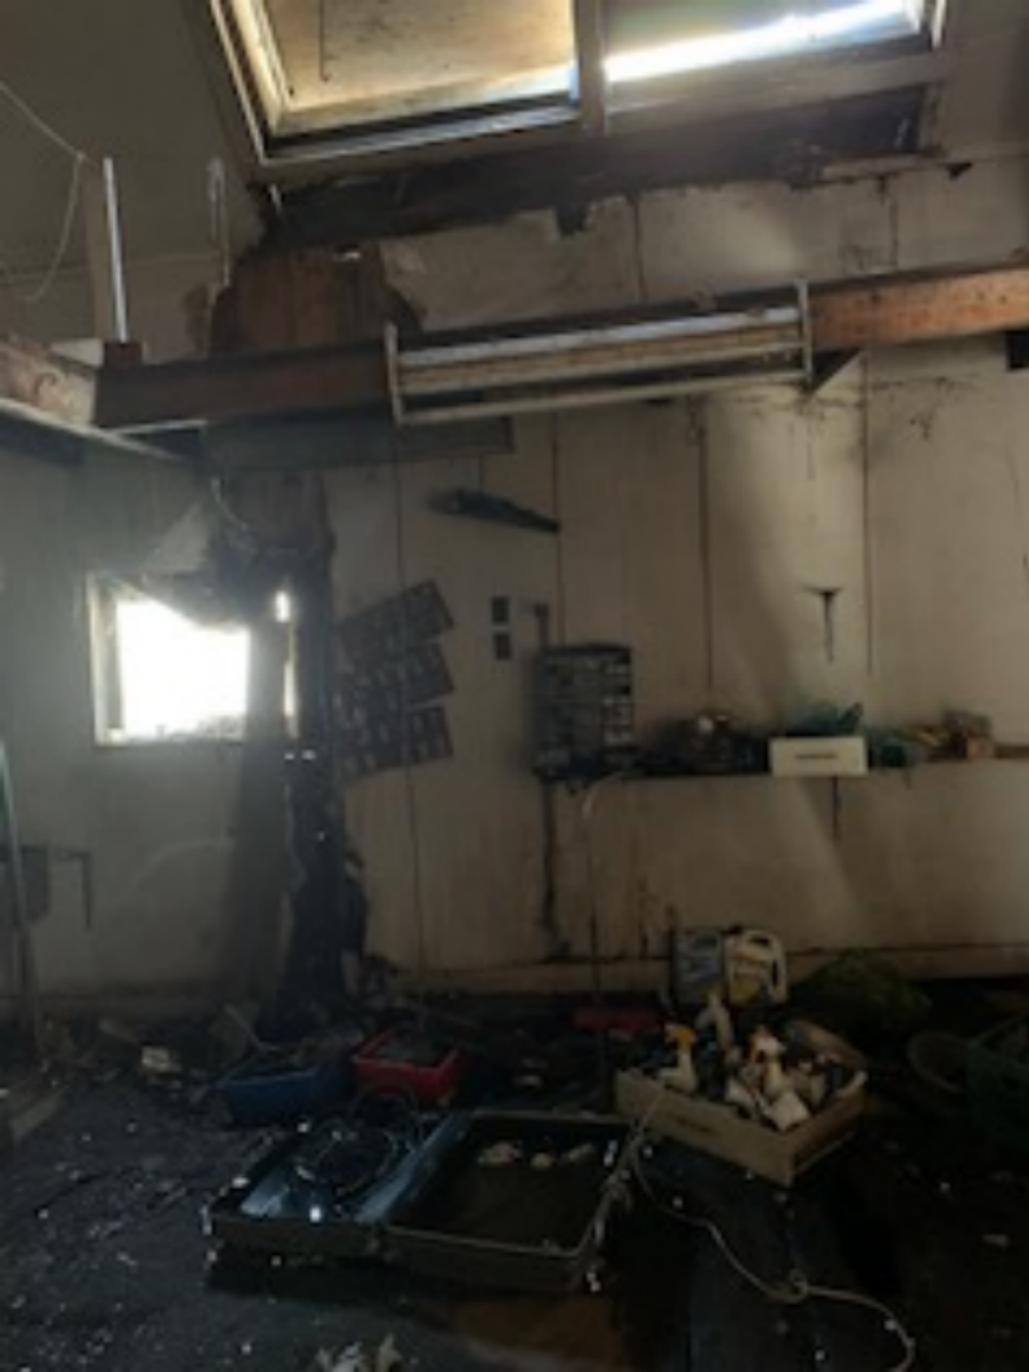
*Photo #4&5: the rotten rafters under the rubber roof, falling in and riddled with mold. The floor is also rotted badly, and sagging considerably. Further evidence of coming collapse.*

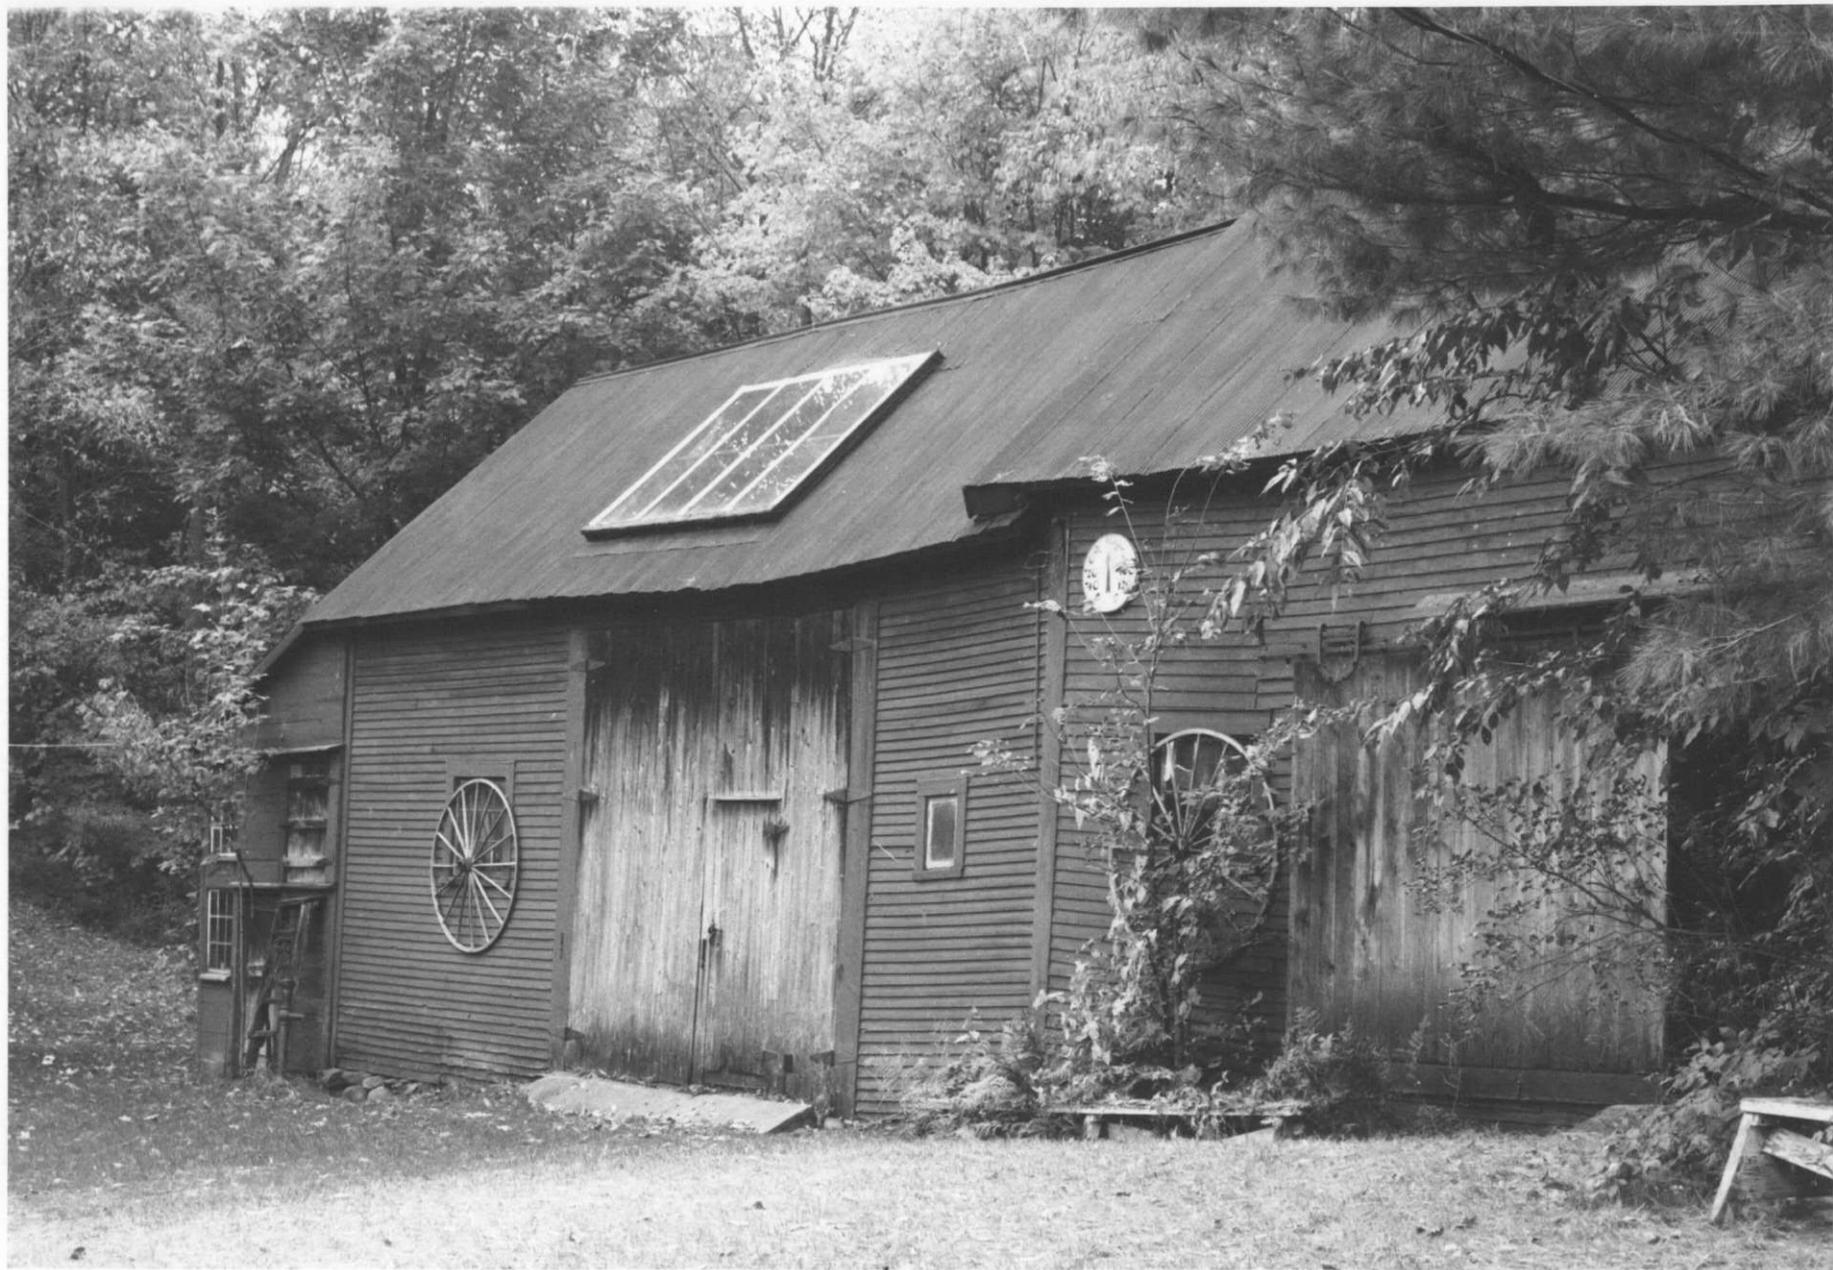
MAP NUMBER: 3	DATE BUILT: c.1890	SURVEY NUMBER: 0808-64
FUNCTIONAL TYPE: shed	NEGATIVE FILE NUMBER: 85-A-487(6,7)	
COMMON NAME: wood shed	OWNER: Stanley Marc and Carolyn S. Wright	
HISTORIC CONTEXTS:		
DESCRIPTION: A vernacular, 1-story, gable roofed, approximately 18'x22', 2x3 bay structure with dimensional lumber frame, vertical board siding, sheet metal roof built over former roof. Structure is built into a bank in the northeast corner. Two-west gable front vertical board hinged doors. Pegged, post and beam door frame under left entrance possibly indicates an earlier nineteenth century construction date for the north side of the shed with the south side having been added later. Three open bays on south eave-side is supported by posts to preserve the aging structure.		
MAP NUMBER: 4	DATE BUILT: c.1870	SURVEY NUMBER: 0808-64
FUNCTIONAL TYPE: Bank Barns	NEGATIVE FILE NUMBER: 85-A-487(10)	
COMMON NAME:	OWNER: Stanley Marc and Carolyn S. Wright

MAP NO. 4, DESCRIPTION cont.:
